## **Re: Structural Analysis Report - Civic Centre Roof Structure, 719 Vernon St., Nelson, BC**

# Structural Analysis Report - Civic Centre Roof Structure, 719 Vernon St., Nelson, BC

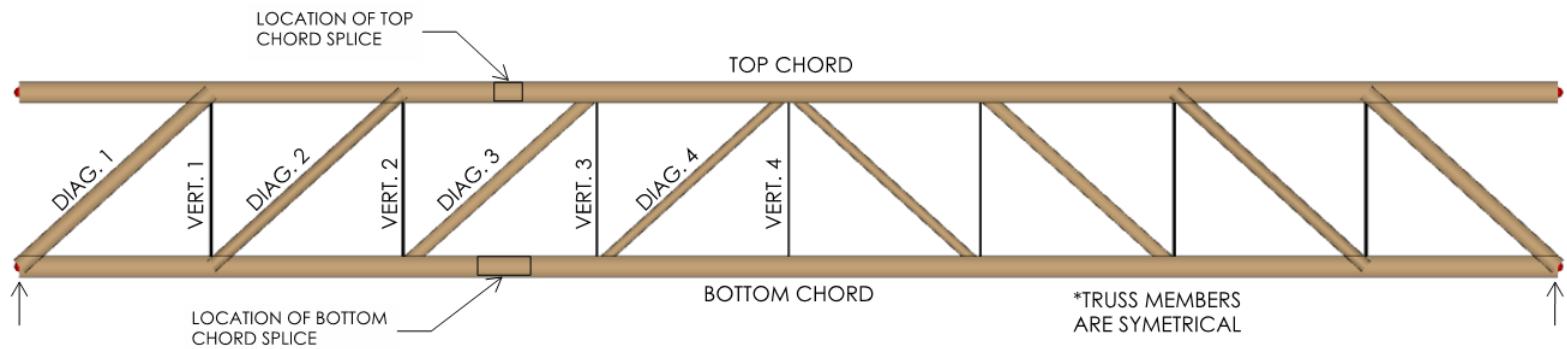
Figure 1 – Typical Truss

In general, all three truss types were found to have insufficient capacity to support the loads specified by the BCBC 2018. Various members have insufficient capacity, but the critical member with the least capacity was the truss bottom chord at the splice connection for all three truss types. If this member were to fail in tension, it would likely be an abrupt brittle failure most likely not showing signs of distress prior to failure. In the attached Appendix A, Tables 1, 2 and 3 breakdown our results for each truss type, for each of the truss members, and we provide the corresponding maximum snow load capacity.

We further recommend that the existing roof structure should actually be strengthened or replaced in order to maintain and preserve the existing Nelson Civic Centre building. The maintenance and roof load monitoring program that is noted above, should only be implemented for this winter 2023 – 2024, if at all possible.
