City of Nelson Water Master Plan 2006

0795.0077.01-R / March 23, 2007

RE: WATER MASTER PLAN

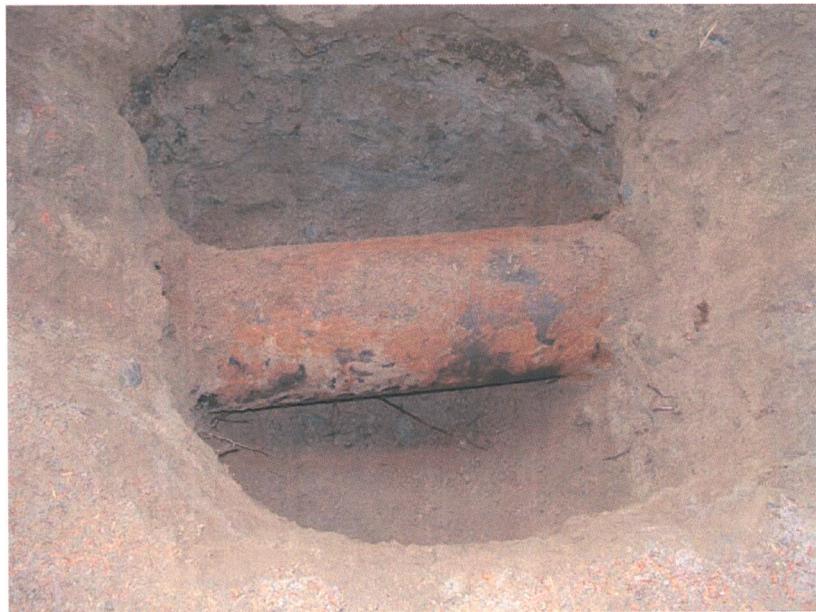
Image 1 – Water Main as Excavated

The pipe coating was estimated to be 80% intact and corrosion product was evident on the pipe surface. Image 1 shows the pipe as excavated at this location.

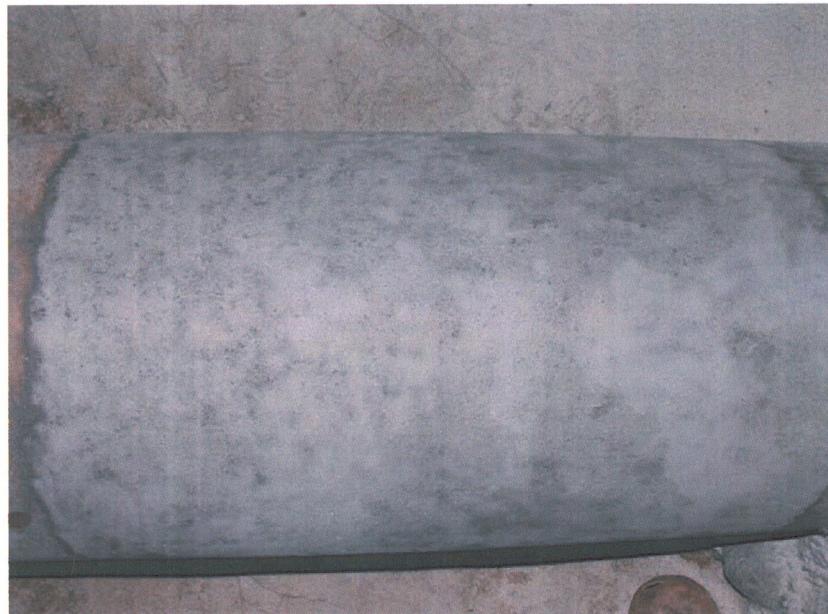
Image 2 – Water Main after Sand Blasting

To allow for further inspection the water main was sand blasted. Image 2 shows the water main after sand blasting. Very small and shallow pits were found on the exterior pipe surface. The pit depths ranged from 10 to 70 mils (0.25 mm to 1.8 mm). The pit depth readings are shown in the field inspection form in Appendix D.

The wall thickness of the pipe was measured using an ultrasonic thickness gage. The readings are detailed in the field inspection form in Appendix D. The wall thickness ranged from 9.2 to 14.1 mm. The average wall thickness was 12.5 mm. According to the original specification the nominal wall thickness is 14.0 mm. Using this value the deepest external pit found has penetrated approximately 13% through the pipe wall. The wall thickness readings indicated that significant thinning from the inside has not occurred in the area tested, with the lowest measurement only 35% below the nominal thickness.

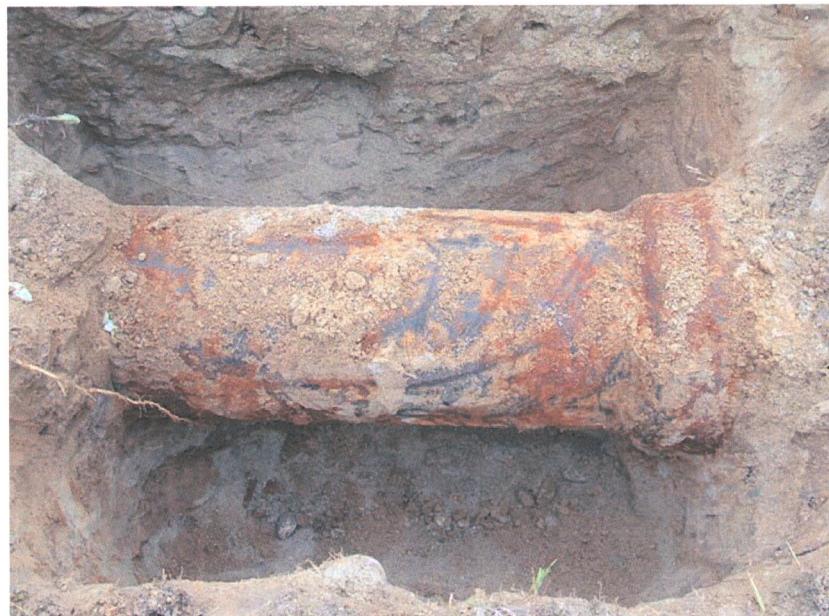
Image 3 – Water Main as Excavated

The pipe coating was estimated to be 75% intact and corrosion product was evident on the pipe surface. Image 3 shows the pipe as excavated at this location.

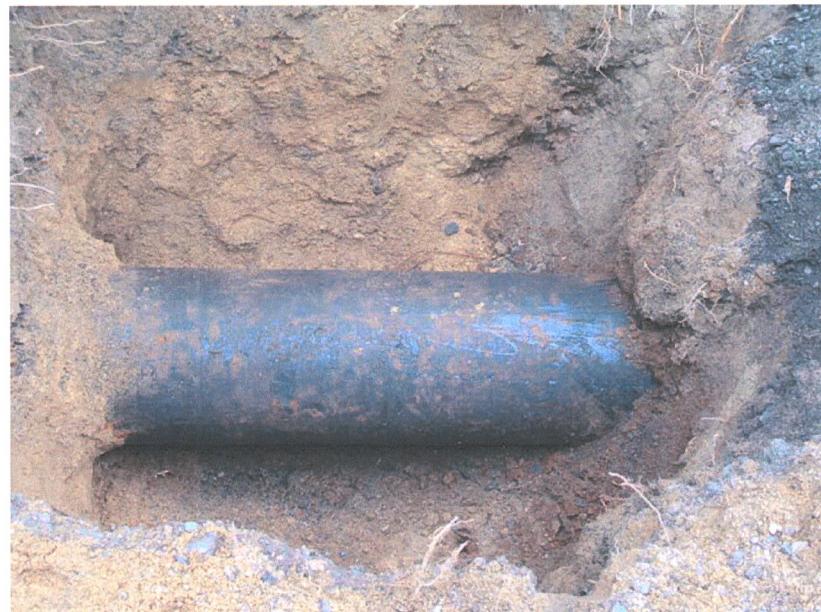
Image 5 – Water Main as Excavated

The pipe coating was estimated to be 85% intact and small amounts of corrosion product were evident on the pipe surface. Image 5 shows the water main as excavated.

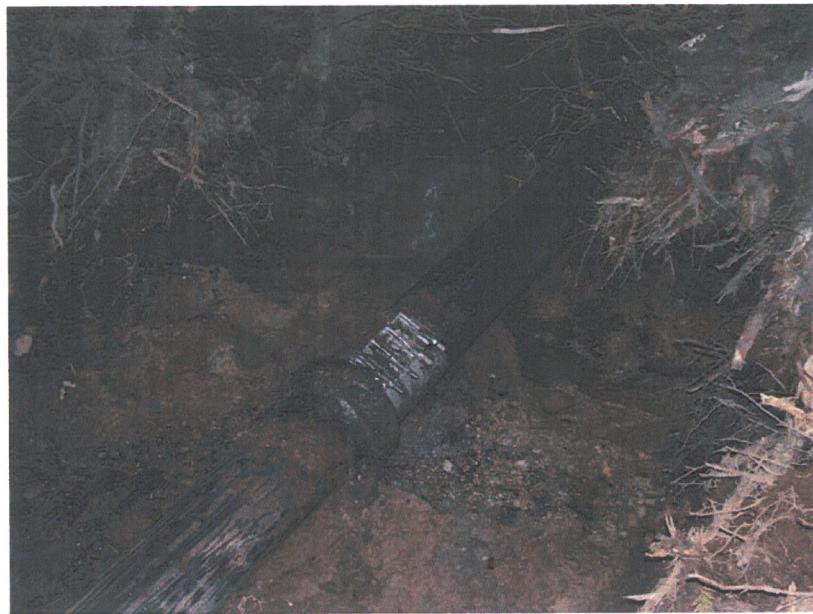
Image 7 – Water Main as Excavated

Test Pit #4 was excavated at chainage 2+425 meters. The pipe at this location was found to be 250 mm diameter. Image 7 below shows the pipe as excavated. The location of this test pit was chosen due to the fact that the pipe was currently leaking. Numerous attempts had been made to repair the leaking joint over time, however all were unsuccessful. Image 7 shows a repair

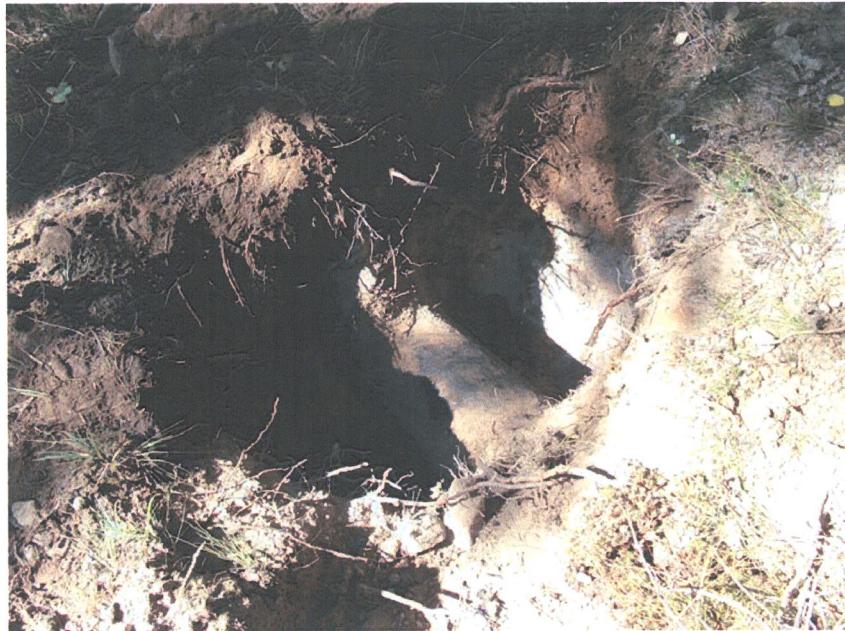
Image 12 – Water Main as Excavated

Test Pit No. 7 was excavated at chainage 4+825 meters. The pipe at this location was 250 mm diameter steel. The coating on the steel pipe was found to be 95% intact and tightly adhered to the pipe surface. The coal tar coating was supplemented with a woven fabric impregnated with coal tar to provide greater strength and durability. Image 12 shows the pipe as excavated.

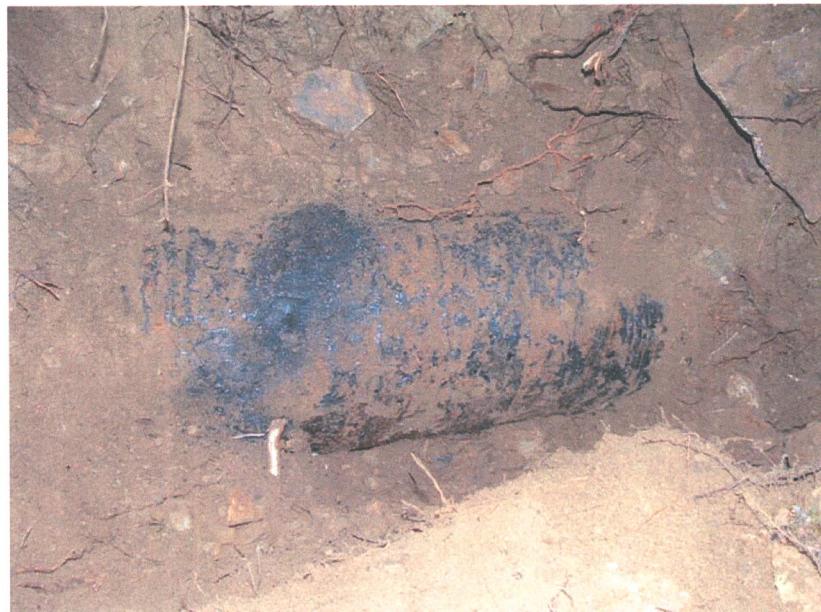
Image 13 – Water Main as Excavated

Sand blasting was not practical at this location, nor was it warranted due to the excellent condition of the pipe coating. Image 13 shows the pipe as excavated at this location.

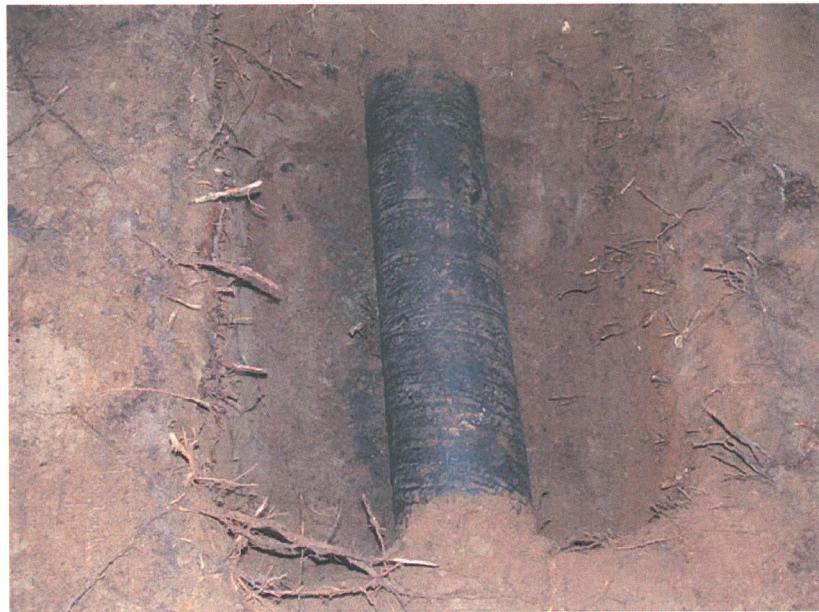
Image 14 – Water Main as Excavated

Test Pit No. 8 was excavated at chainage 5+875 meters. The pipe at this location was 250 mm diameter steel. The coating was estimated to be 95% intact and was tightly adhered to the pipe. Soil samples were taken from the crown and invert of the pipe and tested as per the C105 Standard. The samples both scored 2.0 points and are not considered corrosive. Image 14 shows the pipe as excavated at this location.

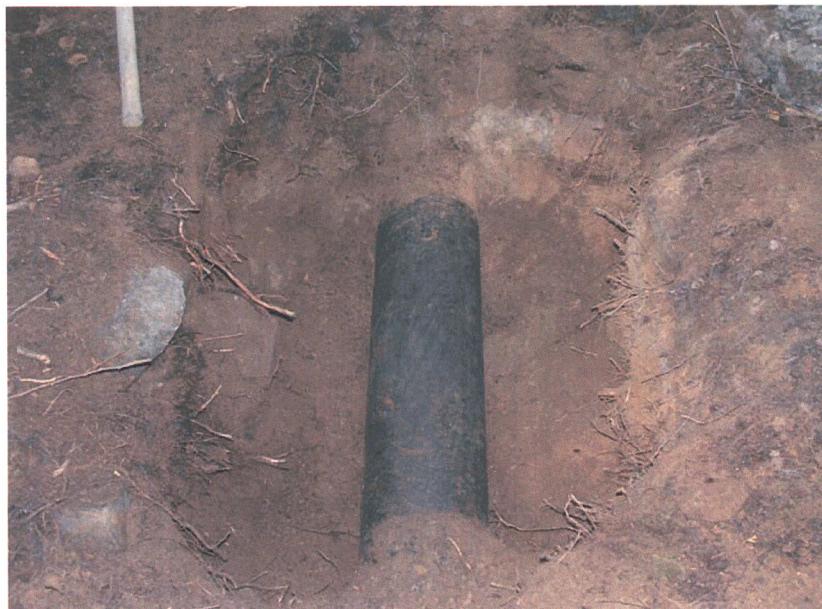
Image 16 – Water Main as Excavated

Test Pit No. 9 was excavated at chainage 6+650 meters. The pipe at this location was 250 mm diameter cast iron. It was estimated that the coating was 90% intact and little or no corrosion product was evident on the pipe surface. Large rocks were found surrounding the main at this location. Soil samples were taken from the crown and invert of the main and tested as per the C105 Standard. The samples both scored 2.0 points and are not considered corrosive to iron pipe. Image 16 shows the pipe as excavated.

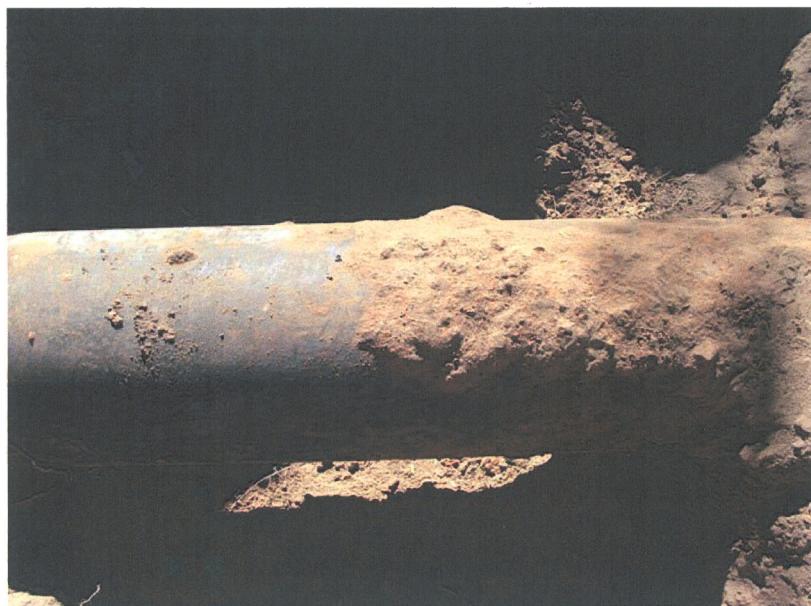
Image 18 – Water Main as Excavated

Test Pit No. 10 was excavated within the reservoir compound at chainage 7+700 meters. According to the drawing provided by the City, the pipe at this location was supposed to be 250 mm diameter steel when in fact the pipe was found to be 300 mm diameter cast iron. The pipe was exposed revealing a heavy layer of corrosion product on the crown of the pipe between 10 o'clock and 2 o'clock. It was estimated that the pipe coating was 70% intact. Image 18 shows the pipe as excavated. Soil samples were taken from the crown and invert of the pipe and tested as per the C105 Standard. The two samples scored 2.0 points and are not considered corrosive to iron pipe.

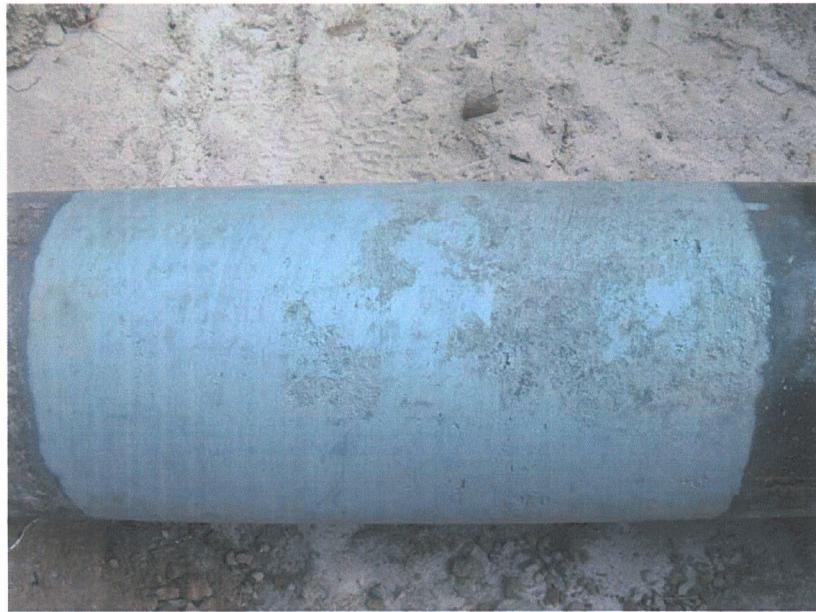
Image 19 – Water Main after Sand Blasting

The corrosion product was removed with hand tools and the pipe was sand blasted. Image 19 shows the pipe after sand blasting. Corrosion pitting was evident on the pipe surface after sand blasting. The depth of the pits were measured using a pit depth gage. The depth of the pits ranged from 10 to 170 mils (0.25 to 4.38mm). The wall thickness of the pipe was measured and ranged from 10.9 mm to 13.9 mm with an average thickness of 12.4 mm. The nominal wall thickness of the 300 mm diameter cast iron pipe was specified to be 14 mm. Therefore the deepest recorded pit has penetrated the wall by approximately 31%. Thinning of the wall from the interior did not appear to be significant from the thickness readings. The lowest thickness measurement indicated thinning of the wall by approximately 22.5%.

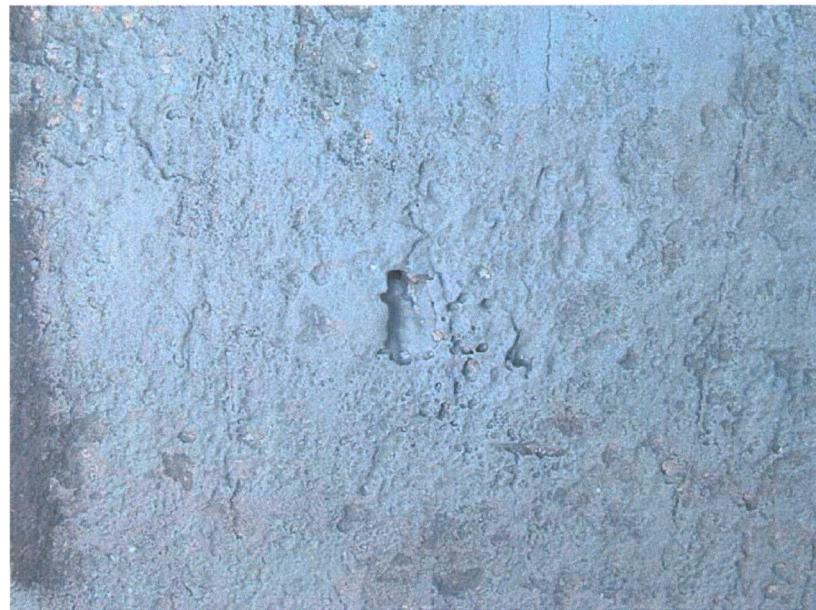
Image 20 – Deep Corrosion Pitting

Image 20 shows the deep corrosion pitting found on the crown of the pipe at this location.

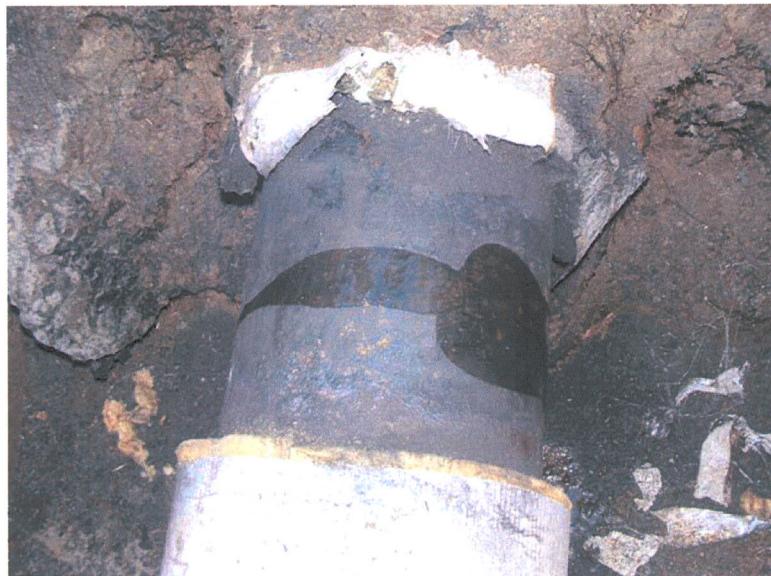
Image 21 – Exposed Water Main within Trestle

The pipe transcends through a concrete coffin under the walkway of the Bealby Trestle between chainage 3+525 meters and 3+550 meters. According to the City of Nelson, the pipe was

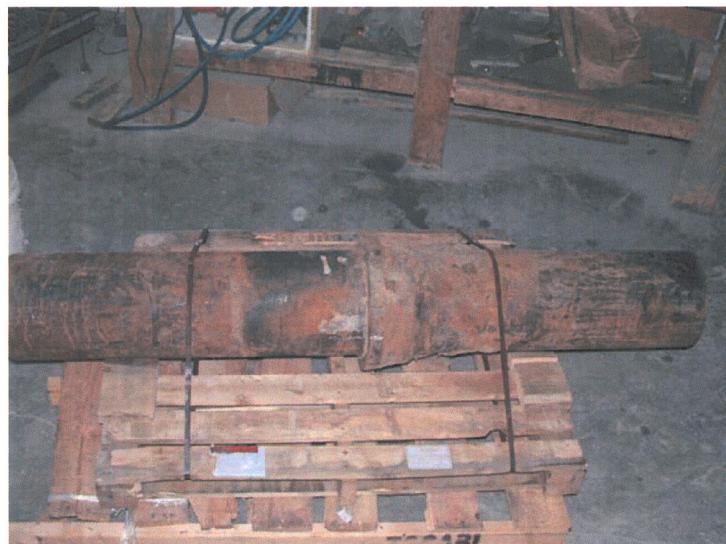
Image 22 – Pipe Sample as Received

The length of pipe removed from Test Pit No. 4 was approximately 1.8 meters. Image 22 shows

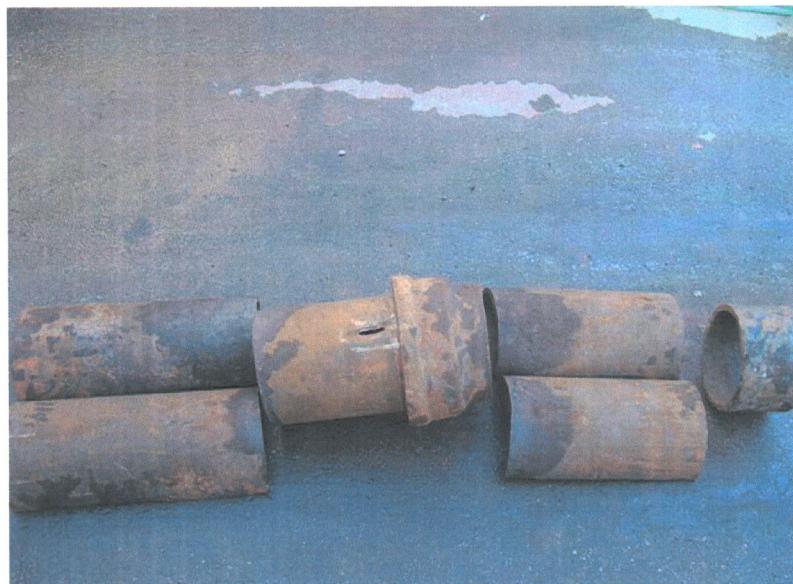
Image 23 – Pipe Sample after Sectioning

The pipe was sectioned into smaller pieces for ease of handling and to allow for inspection of the interior. Image 23 shows the pipe after sectioning. The 200-mm long section shown on the right was sent to the Levelton metallurgical laboratory for physical testing to determine the crush strength of the pipe.

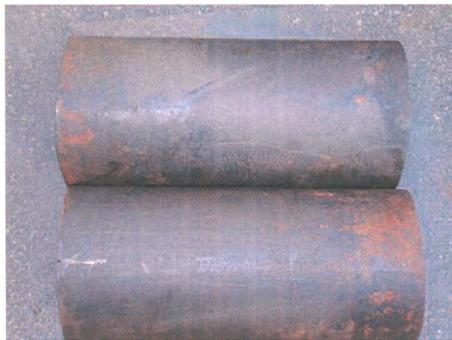
Image 24 – Typical Exterior

After sectioning the pipe was washed with high-pressure water to remove dirt and any corrosion product that was present. It was evident that a black coating was present on both the exterior and interior surfaces of the pipe. In areas where the coating had failed on the exterior, corrosion was evident on the pipe. Images 24 and 25 show the typical appearance of the pipe surface after washing. According to the original project specification provided by the City of Nelson, the pipe was dipped in hot coal tar pitch.

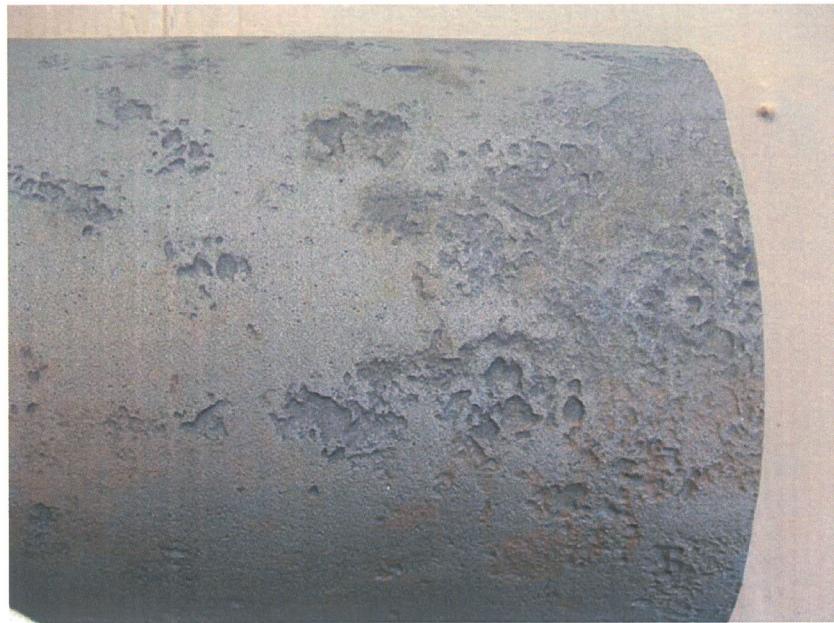
Image 27 – Corrosion Pitting on Exterior Surface

The worst corrosion was found on the exterior surface of the water main. Virtually no corrosion was evident on the interior surface. Image 27 shows the typical corrosion pitting found on the exterior of the pipe.

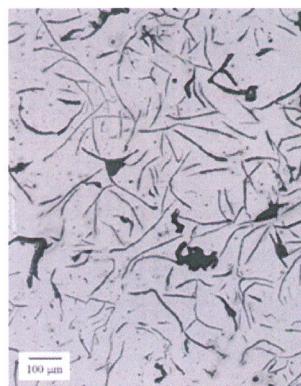
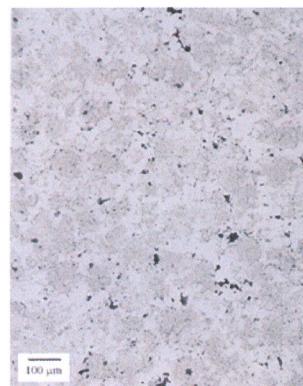
The original specification states that the pipe was manufactured in France, in 1925 in accordance with the "City of Paris Standard". An unsuccessful attempt to find information on this standard was conducted, however due to the vintage of the pipe it is likely that the pipe was pit cast or poured in sand lined molds rather than centrifugally or spun cast. Pit cast pipes tend to have much larger graphite flakes than spun cast pipes (see Image 29).² The graphite flakes are much larger thereby weakening the structure. Therefore smaller flakes and their more uniform distribution in spun cast pipes mean that the pipes are generally significantly stronger than pit cast pipes.

Sand Cast Iron

Spun Cast Iron

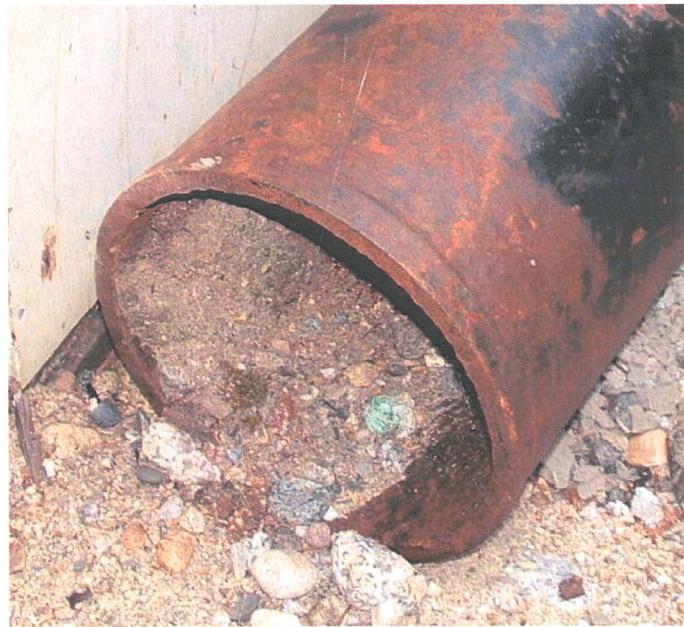
Image 31 – Factory Spigot End

An examination of the pipe joint showed that it was generally in good condition. The joint was a typical bell and spigot, however it appeared that the spigot end was not a factory spigot due to the uneven, rough appearance and the absence of a lip. Image 31 shows the spigot end of a pipe that was never installed, note the lip at the end.

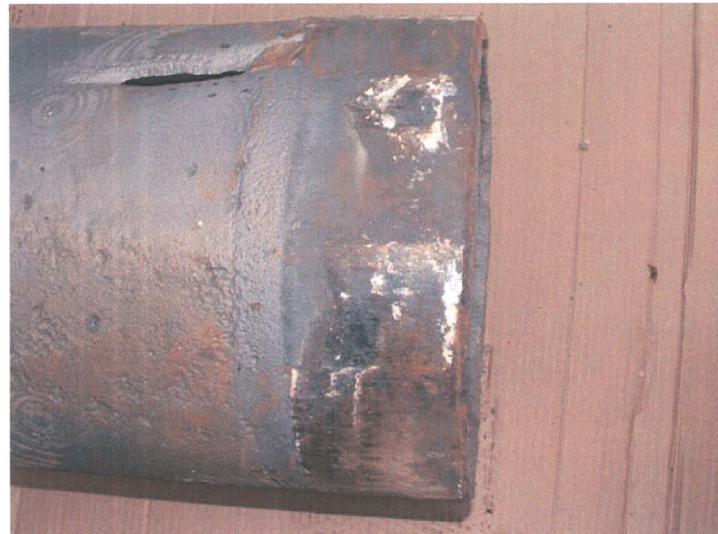
Image 32 – Spigot End of Pipe Sample

Image 32 below shows the spigot end of the pipe within the joint. Note the missing lip and uneven surface.

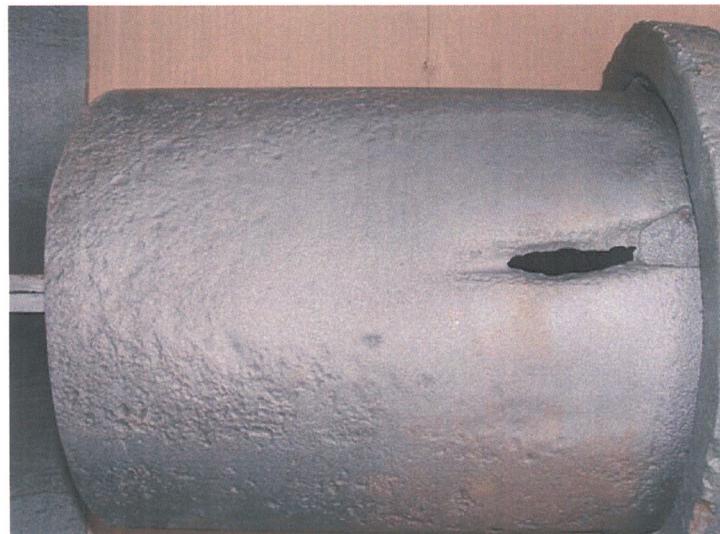
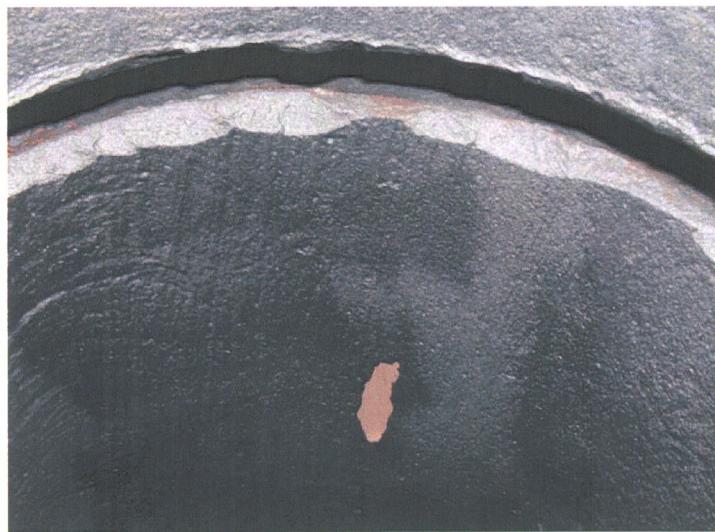
joint, the leaking water, under pressure caused erosion corrosion on the spigot end from the external side. It is not known how long the joint was leaking prior to the erosion hole penetrating through the pipe wall. Images 33 and 34 show the erosion hole from the external and internal surfaces. It is clear that the hole originated from the outside of the pipe and not the inside. Due to the shape and appearance and location of the hole, soil corrosion is not considered to be the cause.

Image 33 – Erosion Hole from Exterior

Image 34 – Erosion Hole from Interior

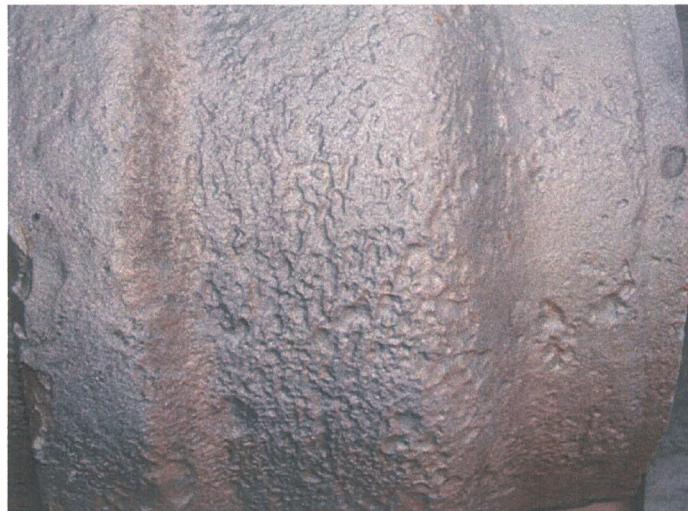
Image 36 – Typical Appearance of the Bell Surface

The bell of the pipe joint is heavily pitted from corrosion, however because of the thickness of the bell, the corrosion has not weakened the pipe in this area. Image 36 shows the typical appearance of the surface of the bell.
